UNITED STATES DISTRICT COURT  
FOR THE EASTERN DISTRICT OF NORTH CAROLINA  
WESTERN DIVISION  
No. 5:15-CR-62-H  
No. 5:15-CR-67-H  
No. 5:15-CR-68-H

UNITED STATES OF AMERICA )  
 )  
 v. ) JOINT FACTUAL STATEMENT  
 )  
DUKE ENERGY BUSINESS SERVICES LLC )  
DUKE ENERGY CAROLINAS, LLC )  
DUKE ENERGY PROGRESS, INC. )

## **II. OVERVIEW AND BACKGROUND**

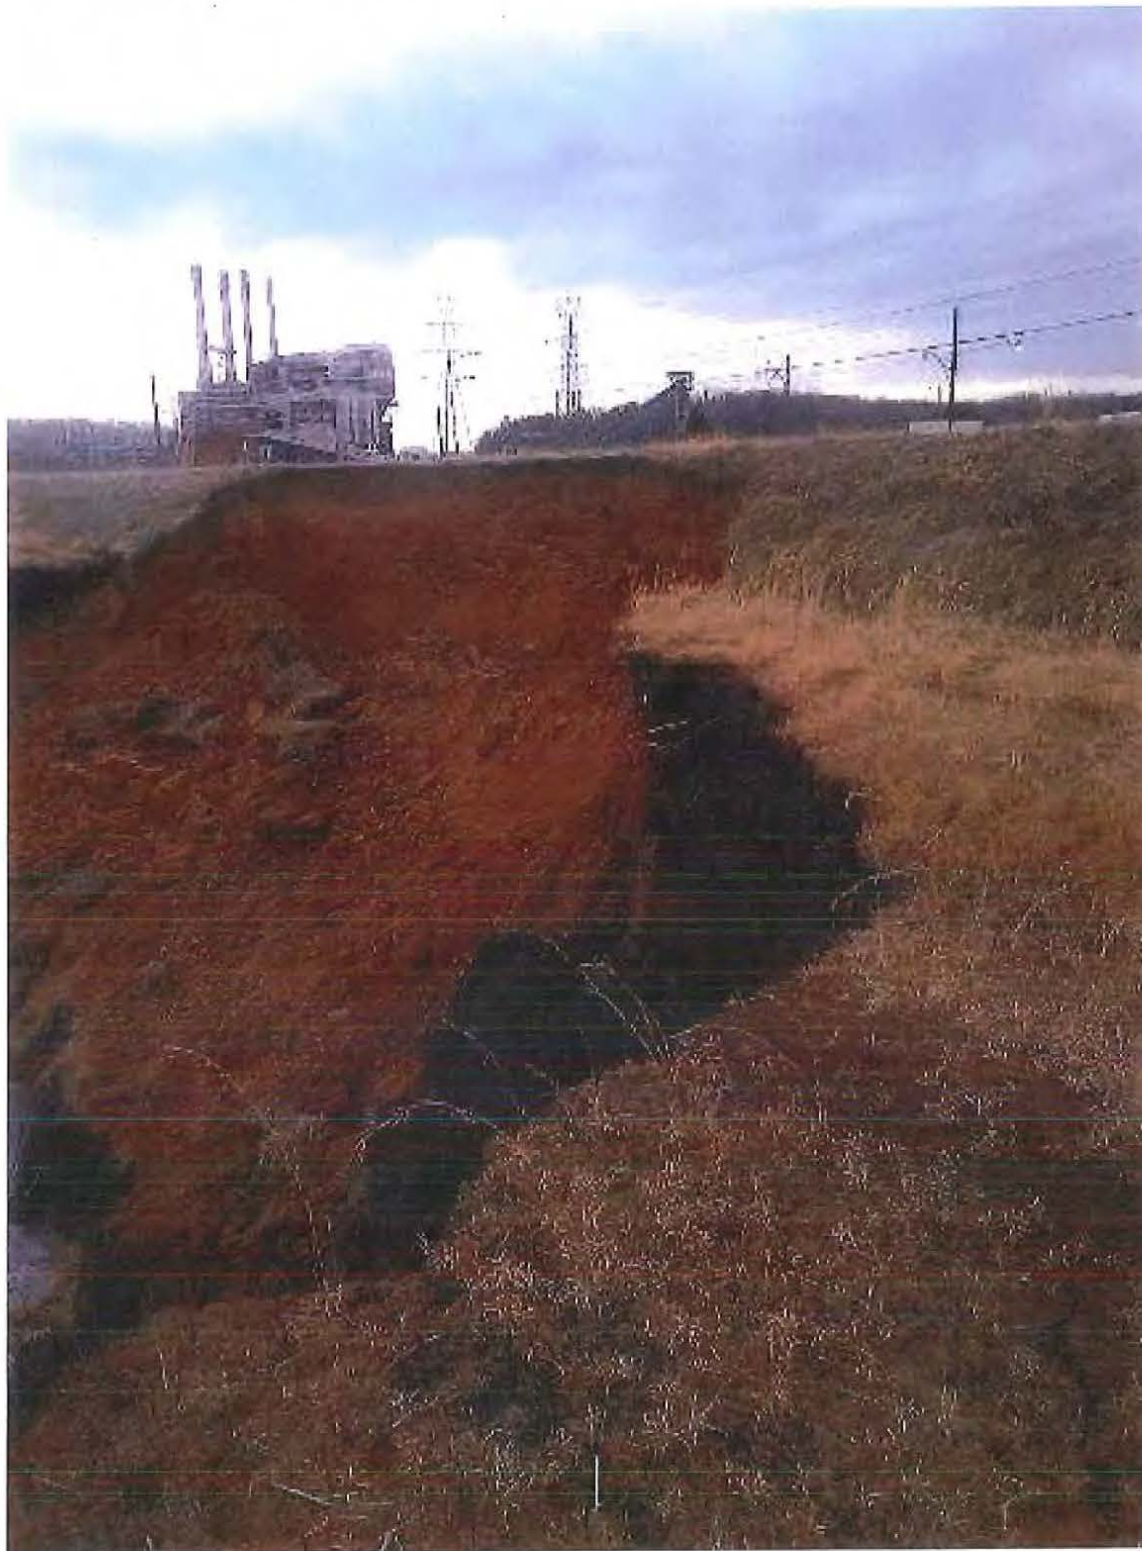
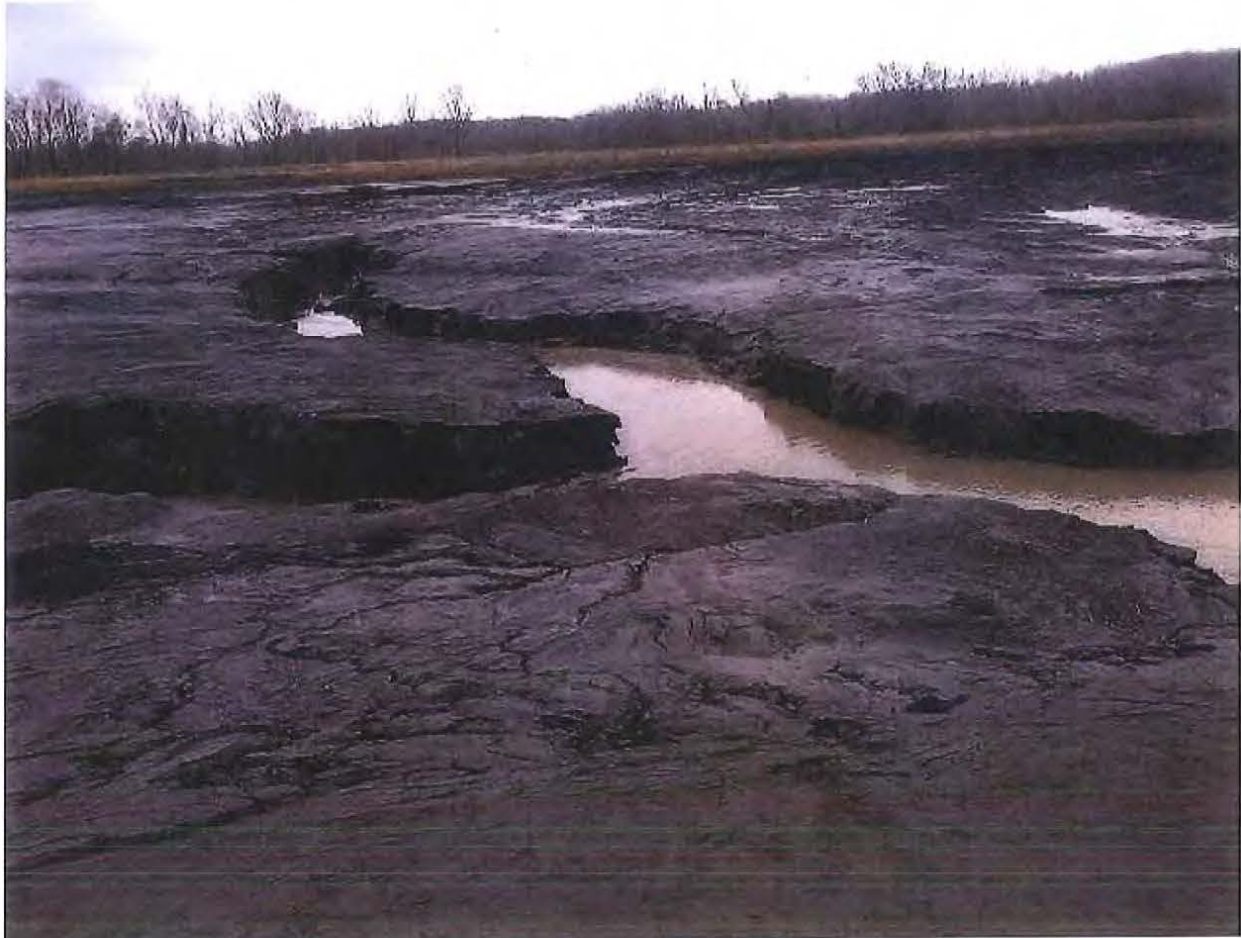
**Photograph 1.** Photograph of DAN RIVER coal ash basin during spill, attached to 2/2/2014, 3:49 p.m. e-mail from Duke Energy Business Services employee.

**Photograph 2.** Photograph of DAN RIVER coal ash basin during spill, attached to 2/2/2014, 3:49 p.m. e-mail from Duke Energy Business Services employee.

**Photograph 3.** Photograph of DAN RIVER coal ash basin during spill, attached to 2/2/2014, 3:49 p.m. e-mail from Duke Energy Business Services employee.

**Photograph 4.** Photograph of DAN RIVER coal ash basin during spill, attached to 2/2/2014, 3:49 p.m. e-mail from Duke Energy Business Services employee.

81. On February 2, 2014, a five-foot long elbow joint within the sixty-year-old corrugated metal section of the 48-inch pipe under the Primary Ash Basin at DAN RIVER failed, resulting in the release of coal ash wastewater and coal ash into the Dan River.

82. Later inspection of the elbow joint, after its retrieval from the Dan River, revealed extensive corrosion of the metal of the elbow joint initiating at the bottom center of the elbow. The parties disagree about some of the factors that contributed to the extensive corrosion. Nevertheless, the age of the pipe was at or beyond the reasonably expected serviceable

life for CMP under similar conditions. Ultimately, the combination of the corrosion and the weight of the coal ash basin over the elbow joint caused it to buckle, fail, and be pushed through the end of the 48-inch stormwater pipe into the Dan River.

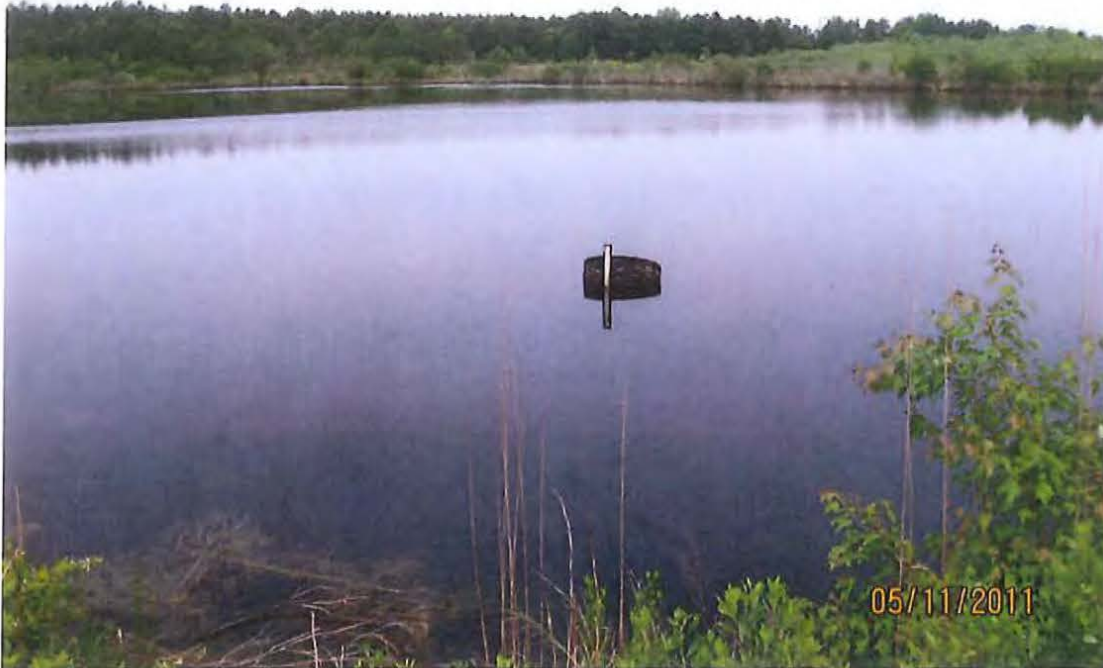
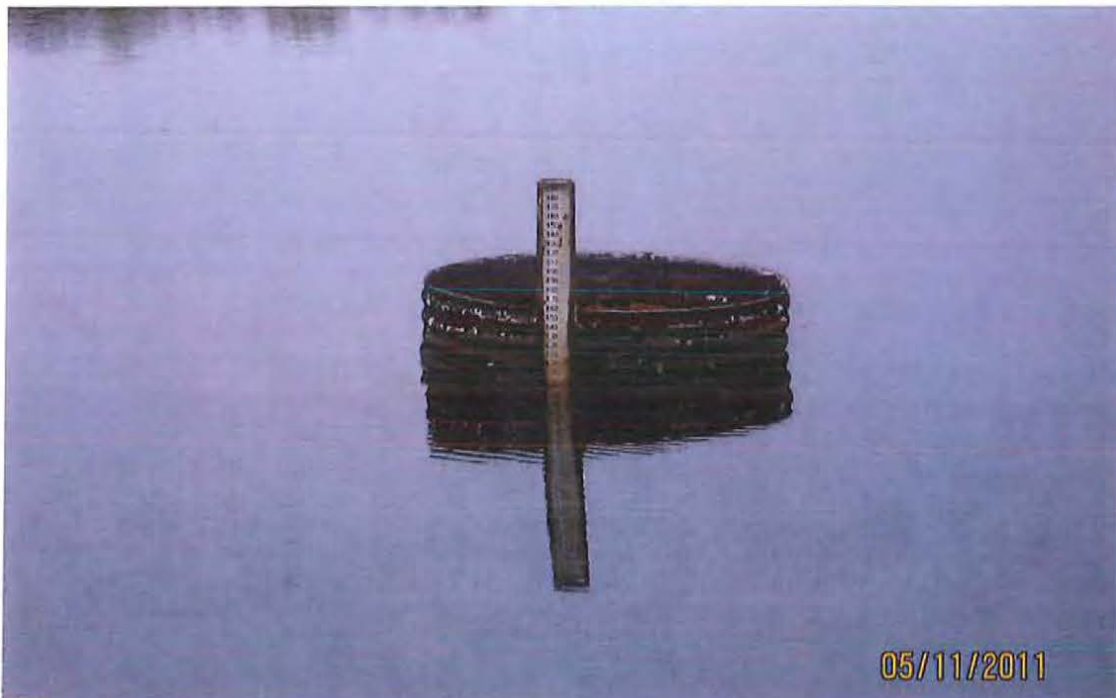
**Photograph 5.** Riser in CAPE FEAR 1978 coal ash basin from 2012 Five Year Independent Consultant Report.

**Photograph 6.** Riser in CAPE FEAR 1978 coal ash basin from 2012 Five Year Independent Consultant Report.

110. The 2012 Five-Year Independent Consultant Report, produced on January 26, 2012, by Engineering Firm #4, noted that the skimmer located at the top of the riser in the 1978 ash basin was corroded and tilted. The skimmer was designed to

113. Annual inspection reports for 2012 and 2013 also reported that the riser in the 1978 ash basin was damaged, deteriorated, and tilted. The annual reports recommended that DUKE ENERGY PROGRESS/Progress Energy Carolinas replace or repair the skimmer on the riser in the 1978 ash basin.

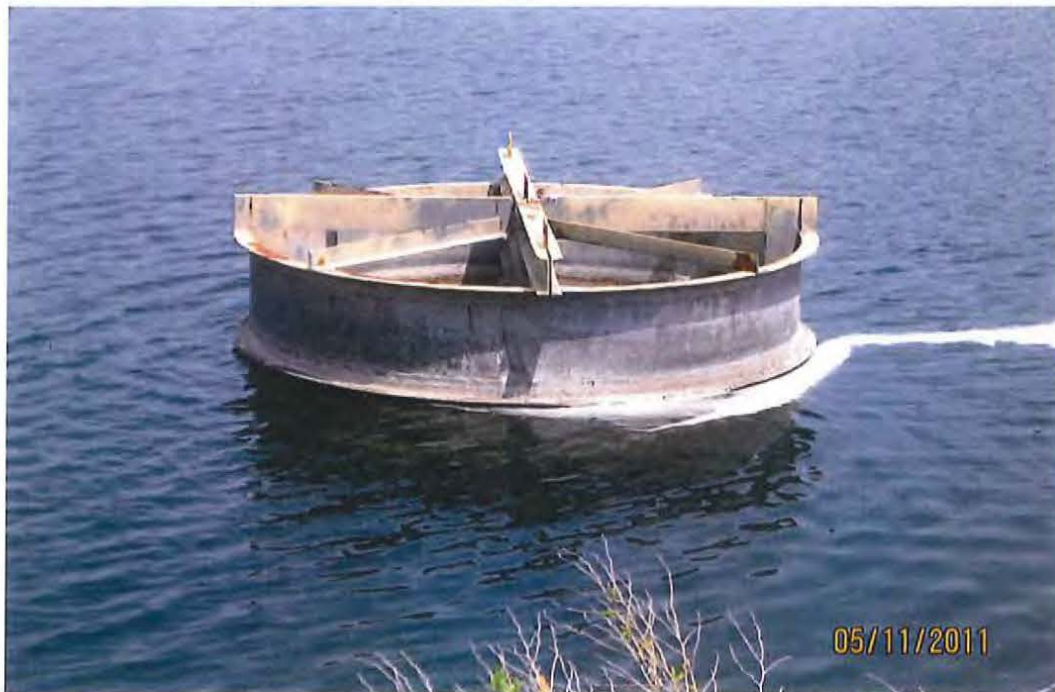
**Photograph 7.** Riser in CAPE FEAR 1985 coal ash basin from 2012 Five Year Independent Consultant Report.

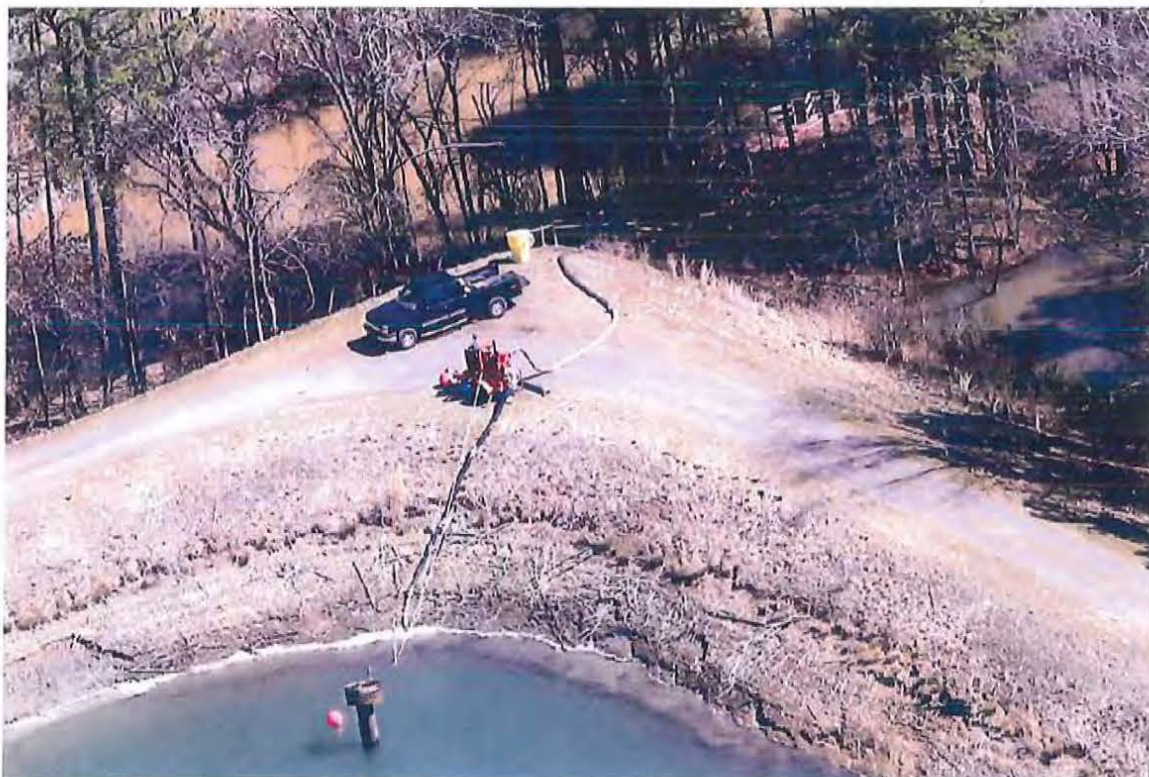
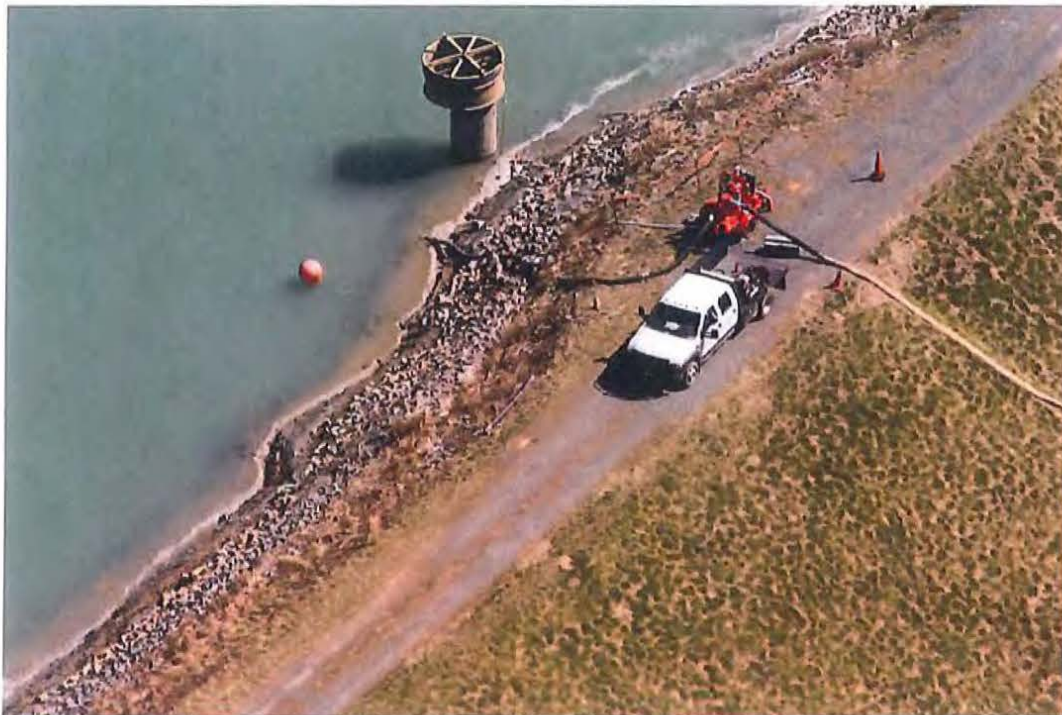
**Photograph 8.** 3/11/14 aerial photograph of CAPE FEAR 1978 coal ash basin with Godwin pump and truck.

Photograph 9. 3/11/14 aerial photograph of CAPE FEAR 1985 coal ash basin with Godwin pump and truck.

**Photograph 10.** 3/11/14 aerial photograph of CAPE FEAR 1985 coal ash basin with Godwin pump and truck.

127. On or about March 11, 2014, DENR officials from both the DWR and the Division of Mineral and Land Resources visited CAPE FEAR to perform an inspection. The DENR officials were accompanied by several DUKE ENERGY PROGRESS and DUKE ENERGY BUSINESS SERVICES employees during their inspection. DENR observed the Godwin pumps at the 1985 and 1978 ash basins along with obvious signs of a significant drop in the water level in the coal ash basins and disturbances in the surface of the coal ash in the basins. **(See Appendix, Photographs 8 - 10).**

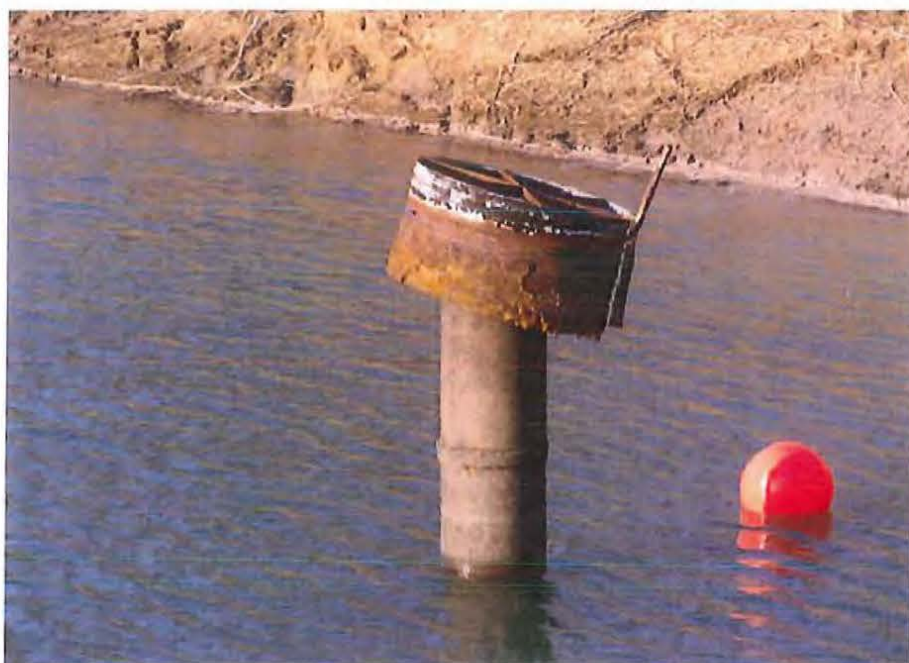
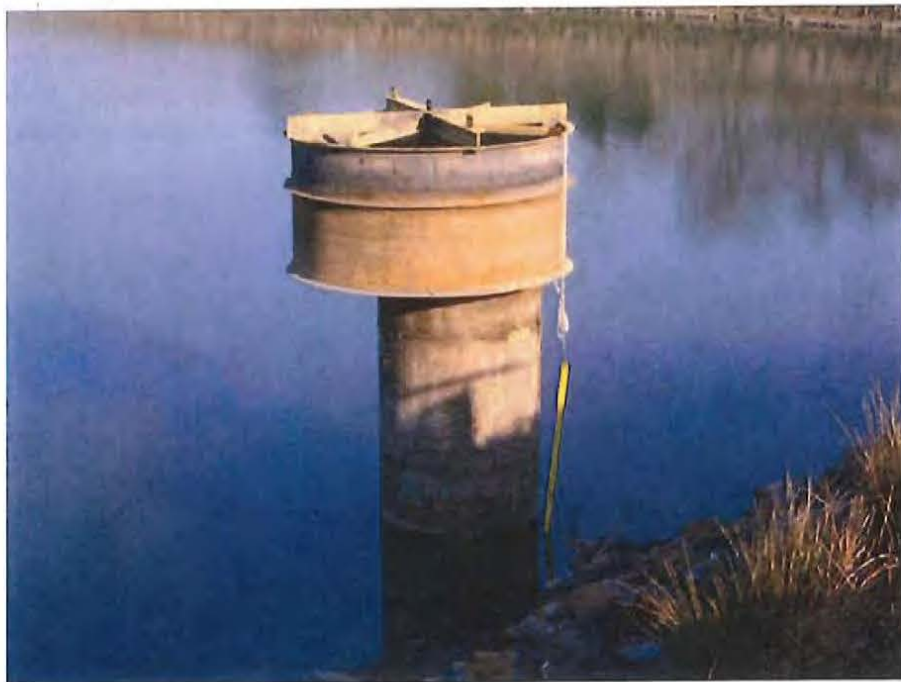
**Photograph 11.** 3/19/14 photograph of CAPE FEAR 1978 coal ash basin riser, prior to repair work.

**Photograph 12.** 3/19/14 photograph of CAPE FEAR 1985 coal ash basin riser, prior to repair work.

131. On or about March 19 and 20, 2014, employees and agents of the underwater pipe repair contractor replaced and resealed the grout between the concrete pipe sections of the risers in the 1978 and 1985 coal ash basins. **(See Appendix, Photographs 11 through 14).**

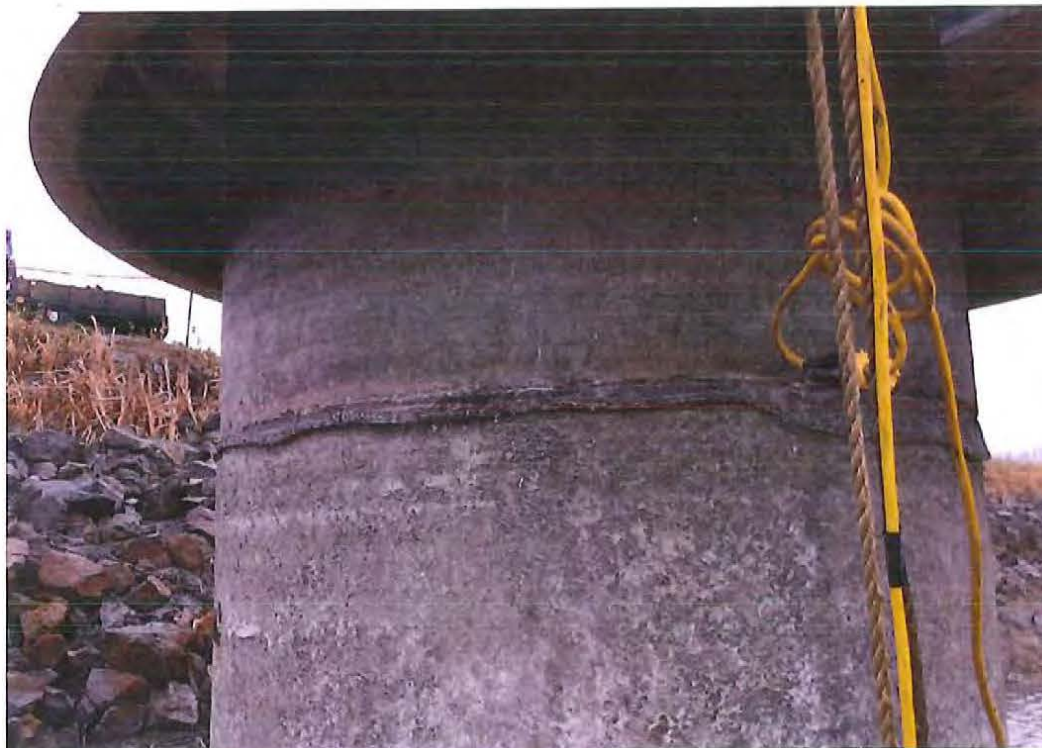
**Photograph 13.** 3/19/14 photograph of old grout on CAPE FEAR coal ash basin riser.

for contractors performing repair work. DUKE ENERGY PROGRESS and DUKE ENERGY BUSINESS SERVICES employees knew that the leaks in the risers were likely being caused by cracks or failures in the grout between the concrete pipe sections that were underwater. The employees did not know how far underwater the leaks or grout failures were or how many sections of the pipe would need repair. Because the risers were filled with air but surrounded by water, underwater repair of the risers could be hazardous to the divers due to a phenomenon known as "differential pressure." DUKE ENERGY PROGRESS and DUKE ENERGY BUSINESS SERVICES employees believed that removing the standing water from the 1978 and 1985 basins to at or below the level of the leaking portions of the risers would eliminate the risk from differential pressure.

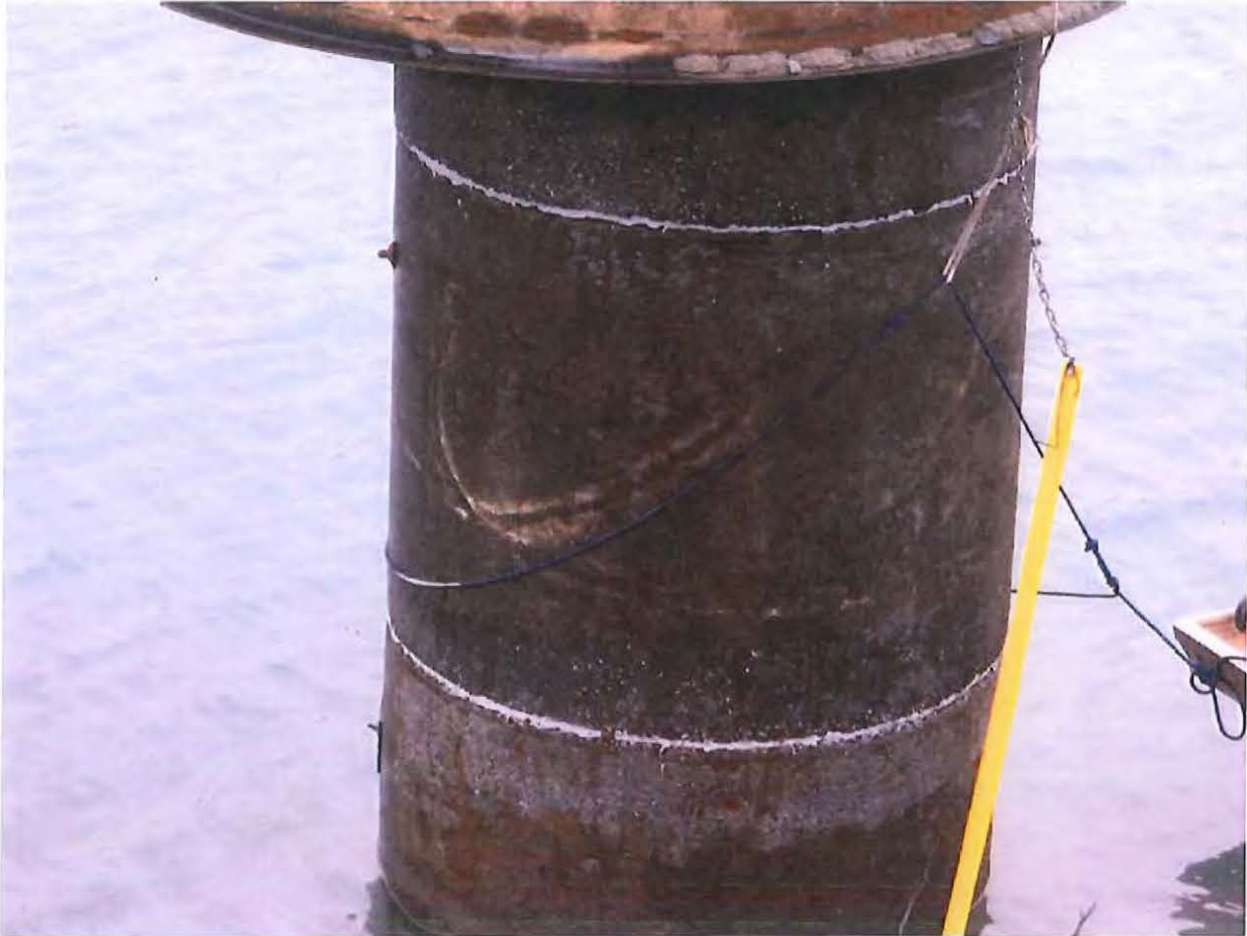
**Photograph 14.** 3/19/14 photograph of new grout on CAPE FEAR coal ash basin riser.

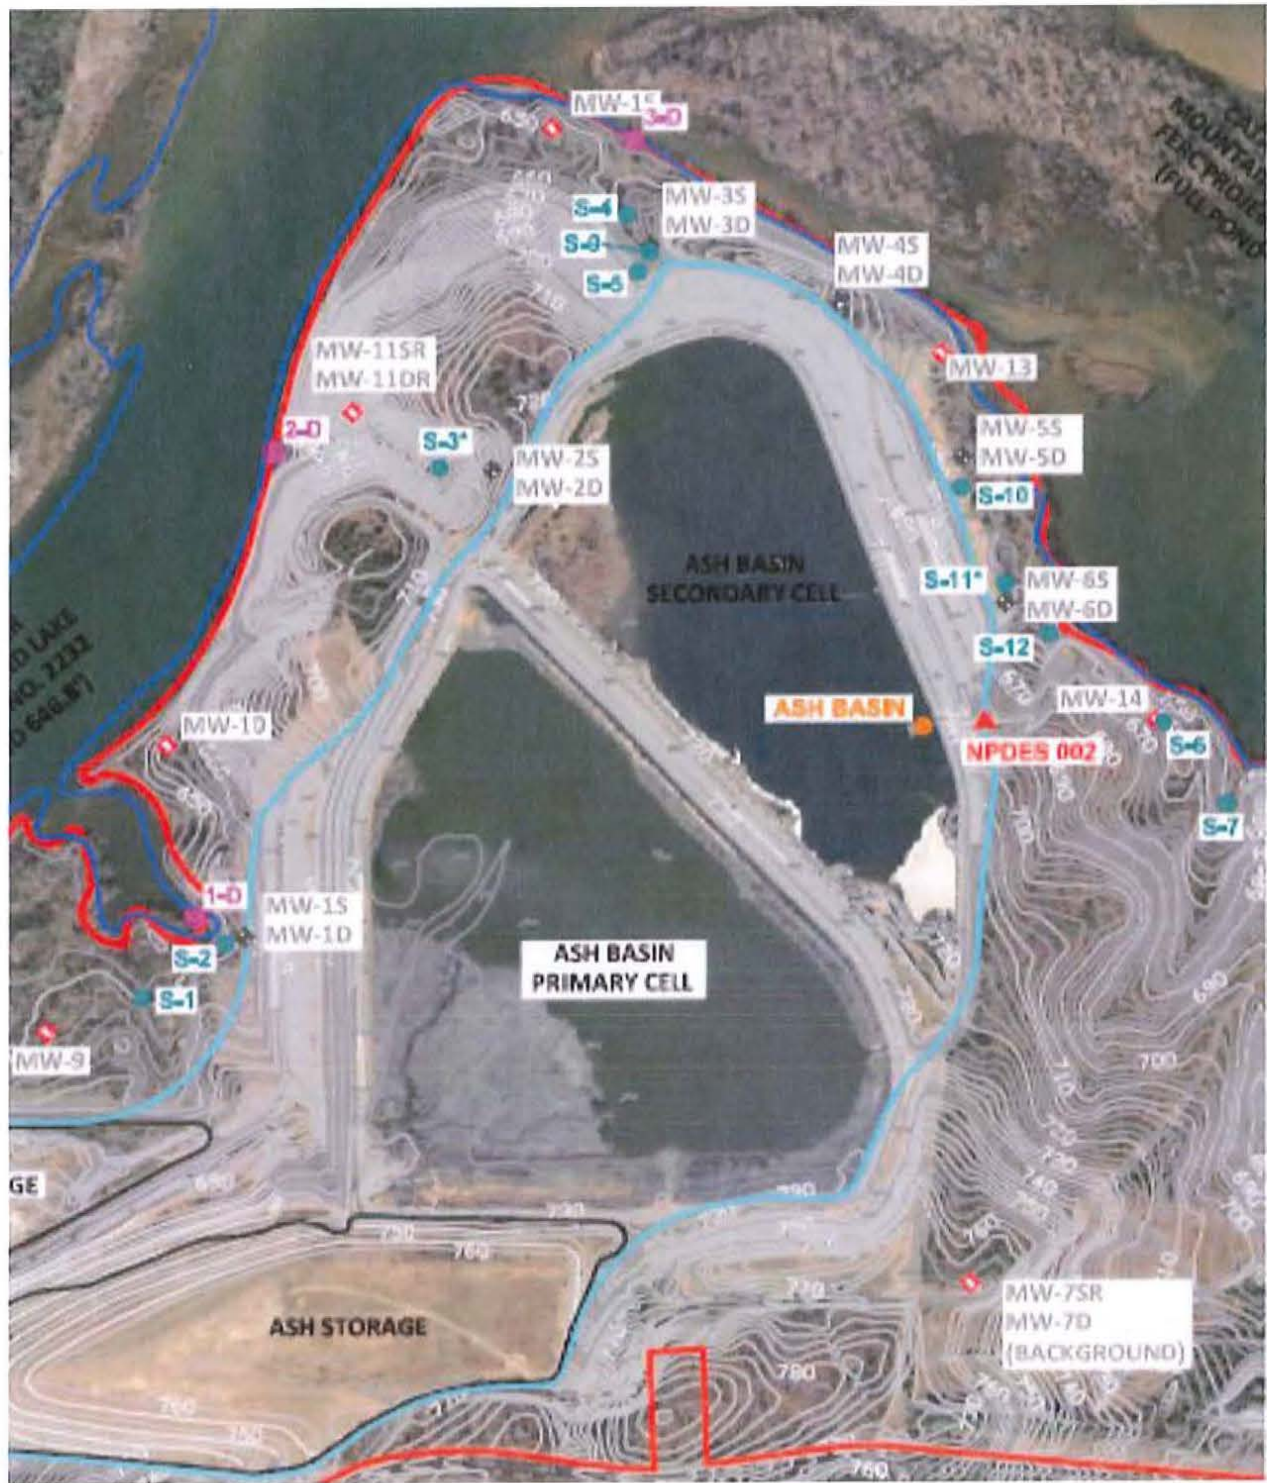
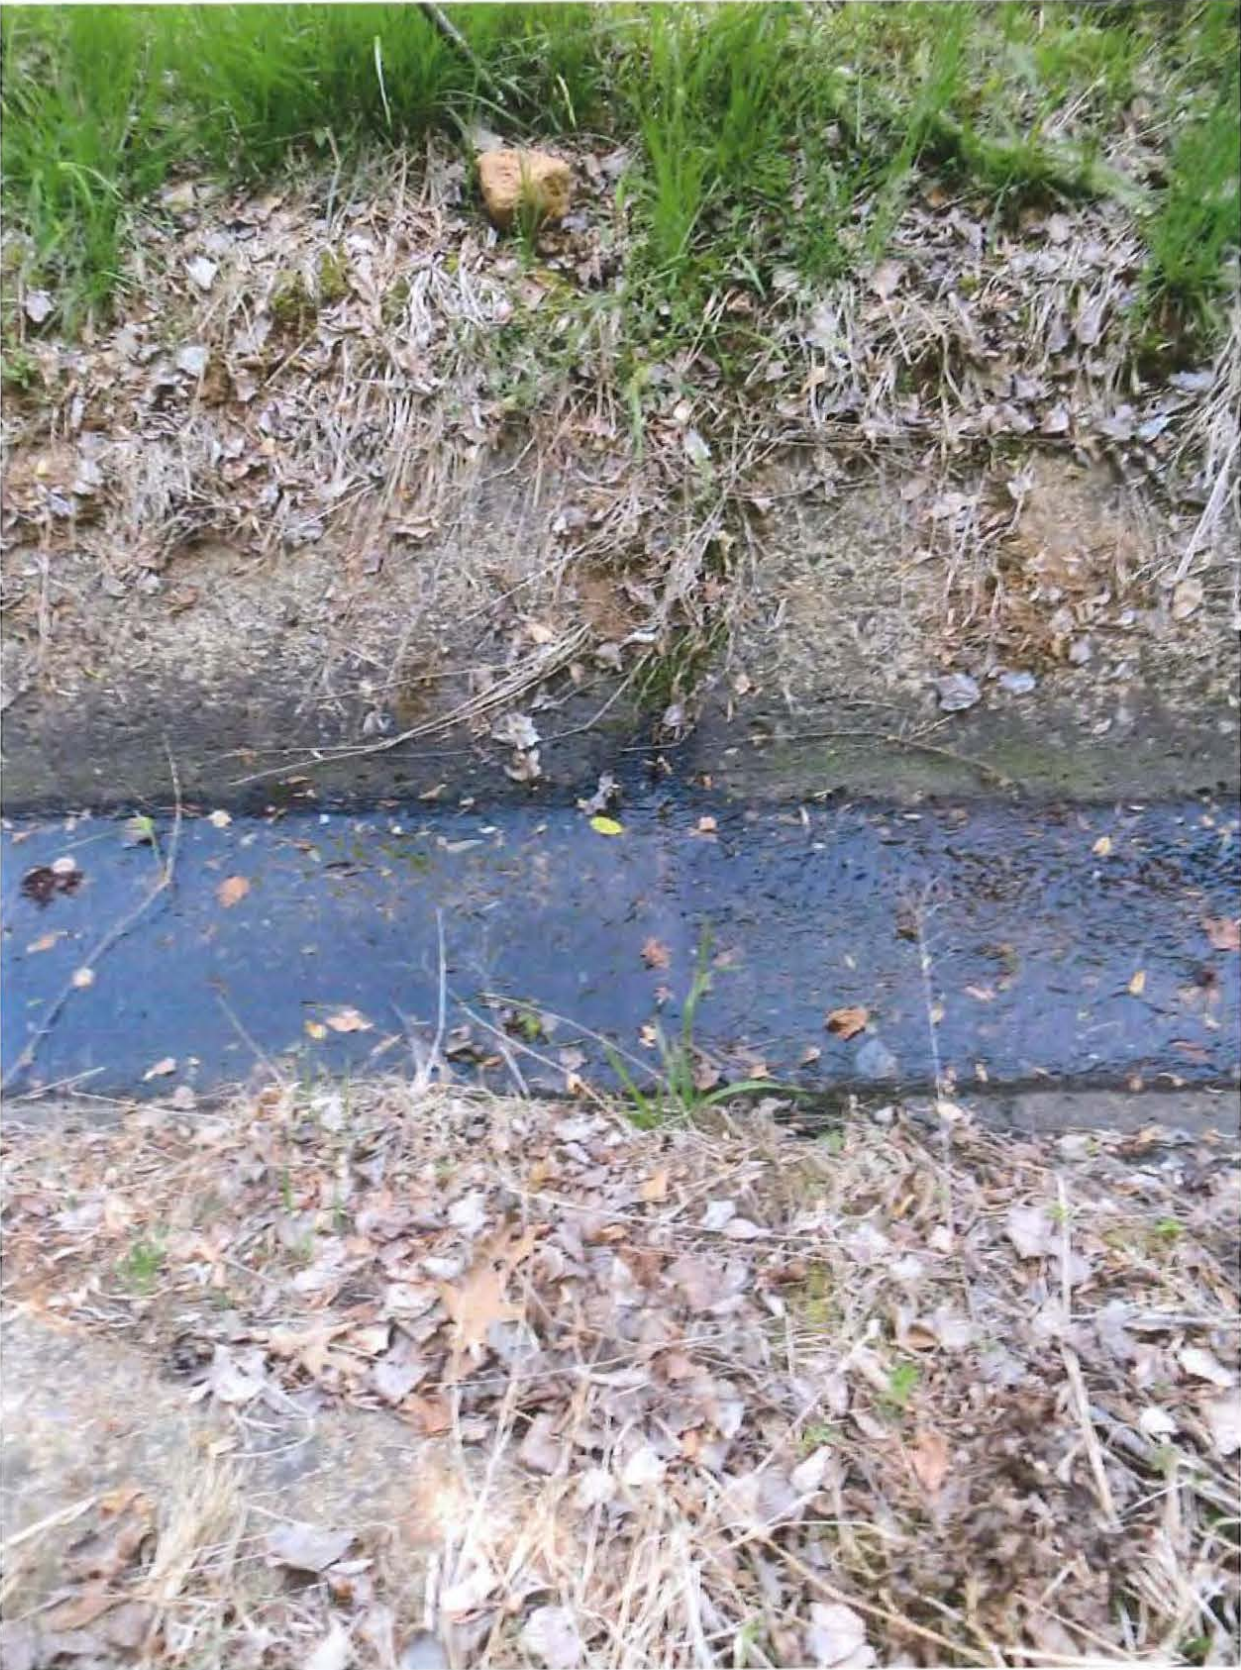
Photograph 16. Aerial photograph depicting location of RIVERBEND Seep 12.

Photograph 17. Photograph of RIVERBEND Seep 12.

Photograph 18. Photograph of RIVERBEND Seep 12.
