UNITED STATES DISTRICT COURT
FOR THE EASTERN DISTRICT OF NORTH CAROLINA
WESTERN DIVISION
No. 5:15-CR-62-H
No. 5:15-CR-67-H
No. 5:15-CR-68-H

UNITED STATES OF AMERICA)
)
 v.) JOINT FACTUAL STATEMENT
)
DUKE ENERGY BUSINESS SERVICES LLC)
DUKE ENERGY CAROLINAS, LLC)
DUKE ENERGY PROGRESS, INC.)

II. OVERVIEW AND BACKGROUND

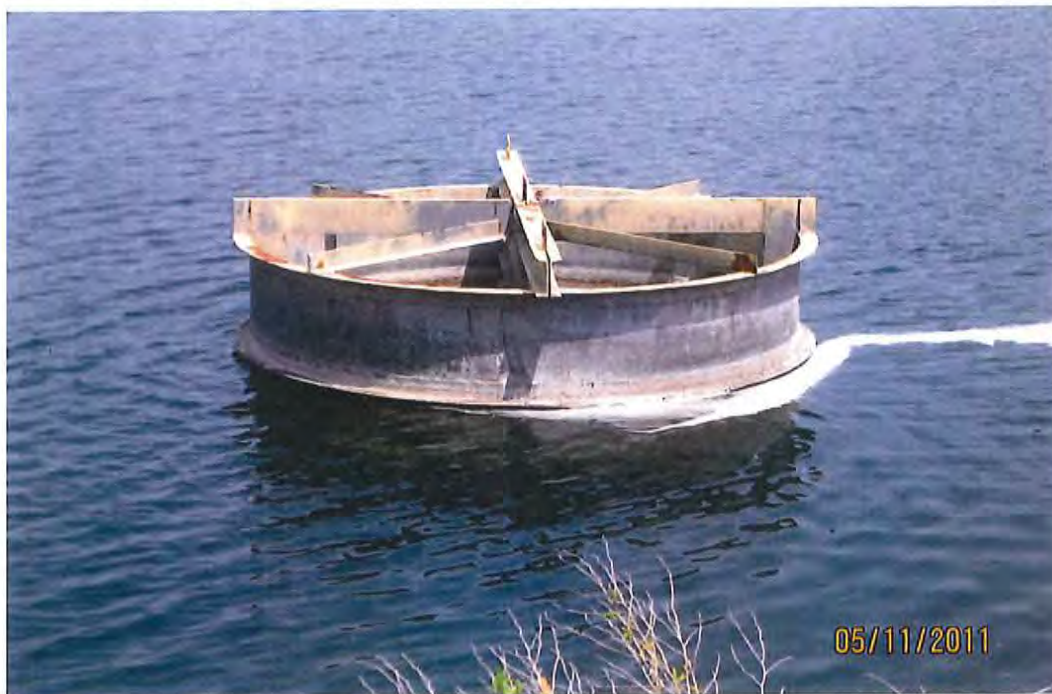
Photograph 7. Riser in CAPE FEAR 1985 coal ash basin from 2012 Five Year Independent Consultant Report.

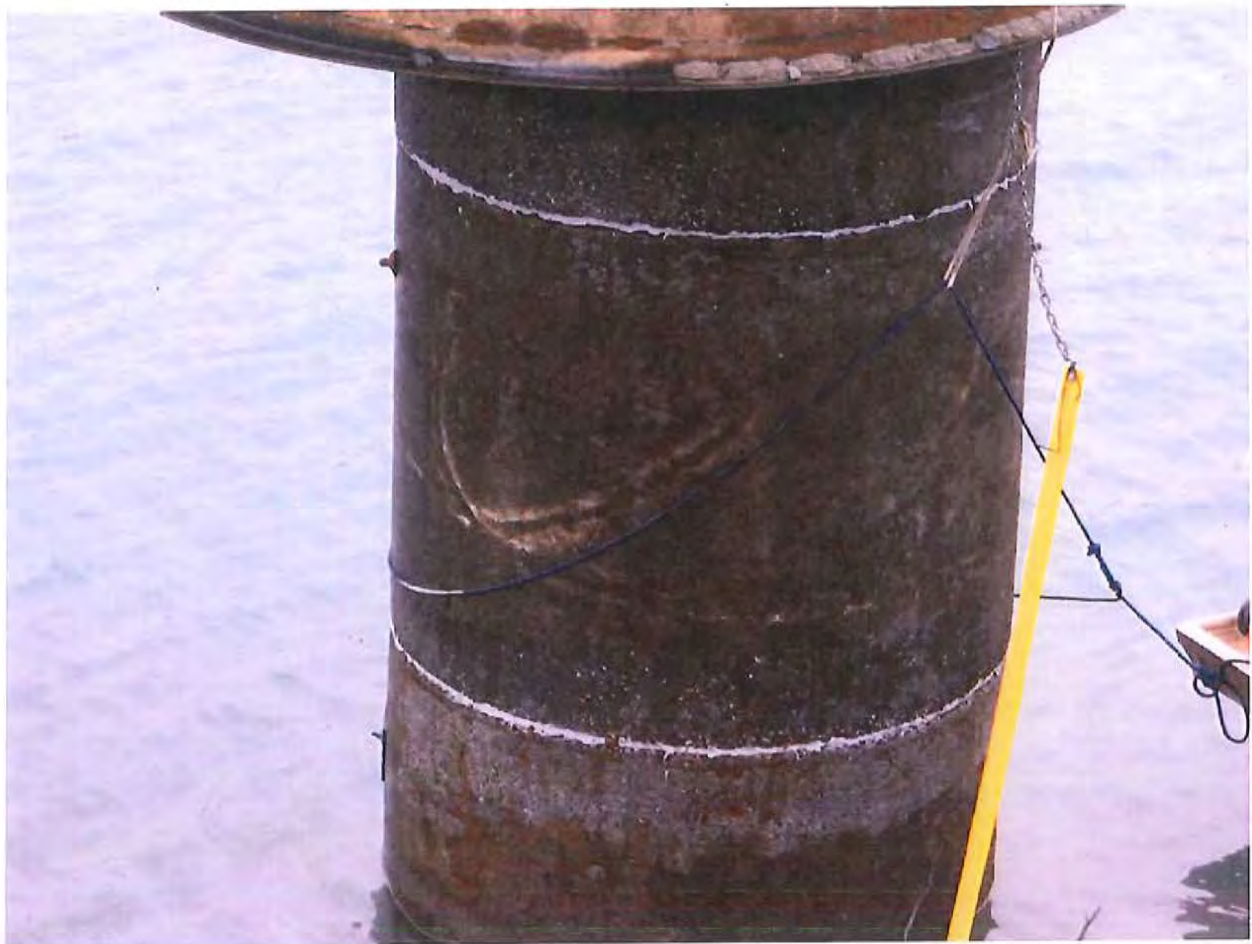
Photograph 14. 3/19/14 photograph of new grout on CAPE FEAR coal ash basin riser.

131. On or about March 19 and 20, 2014, employees and agents of the underwater pipe repair contractor replaced and resealed the grout between the concrete pipe sections of the risers in the 1978 and 1985 coal ash basins. **(See Appendix, Photographs 11 through 14).**

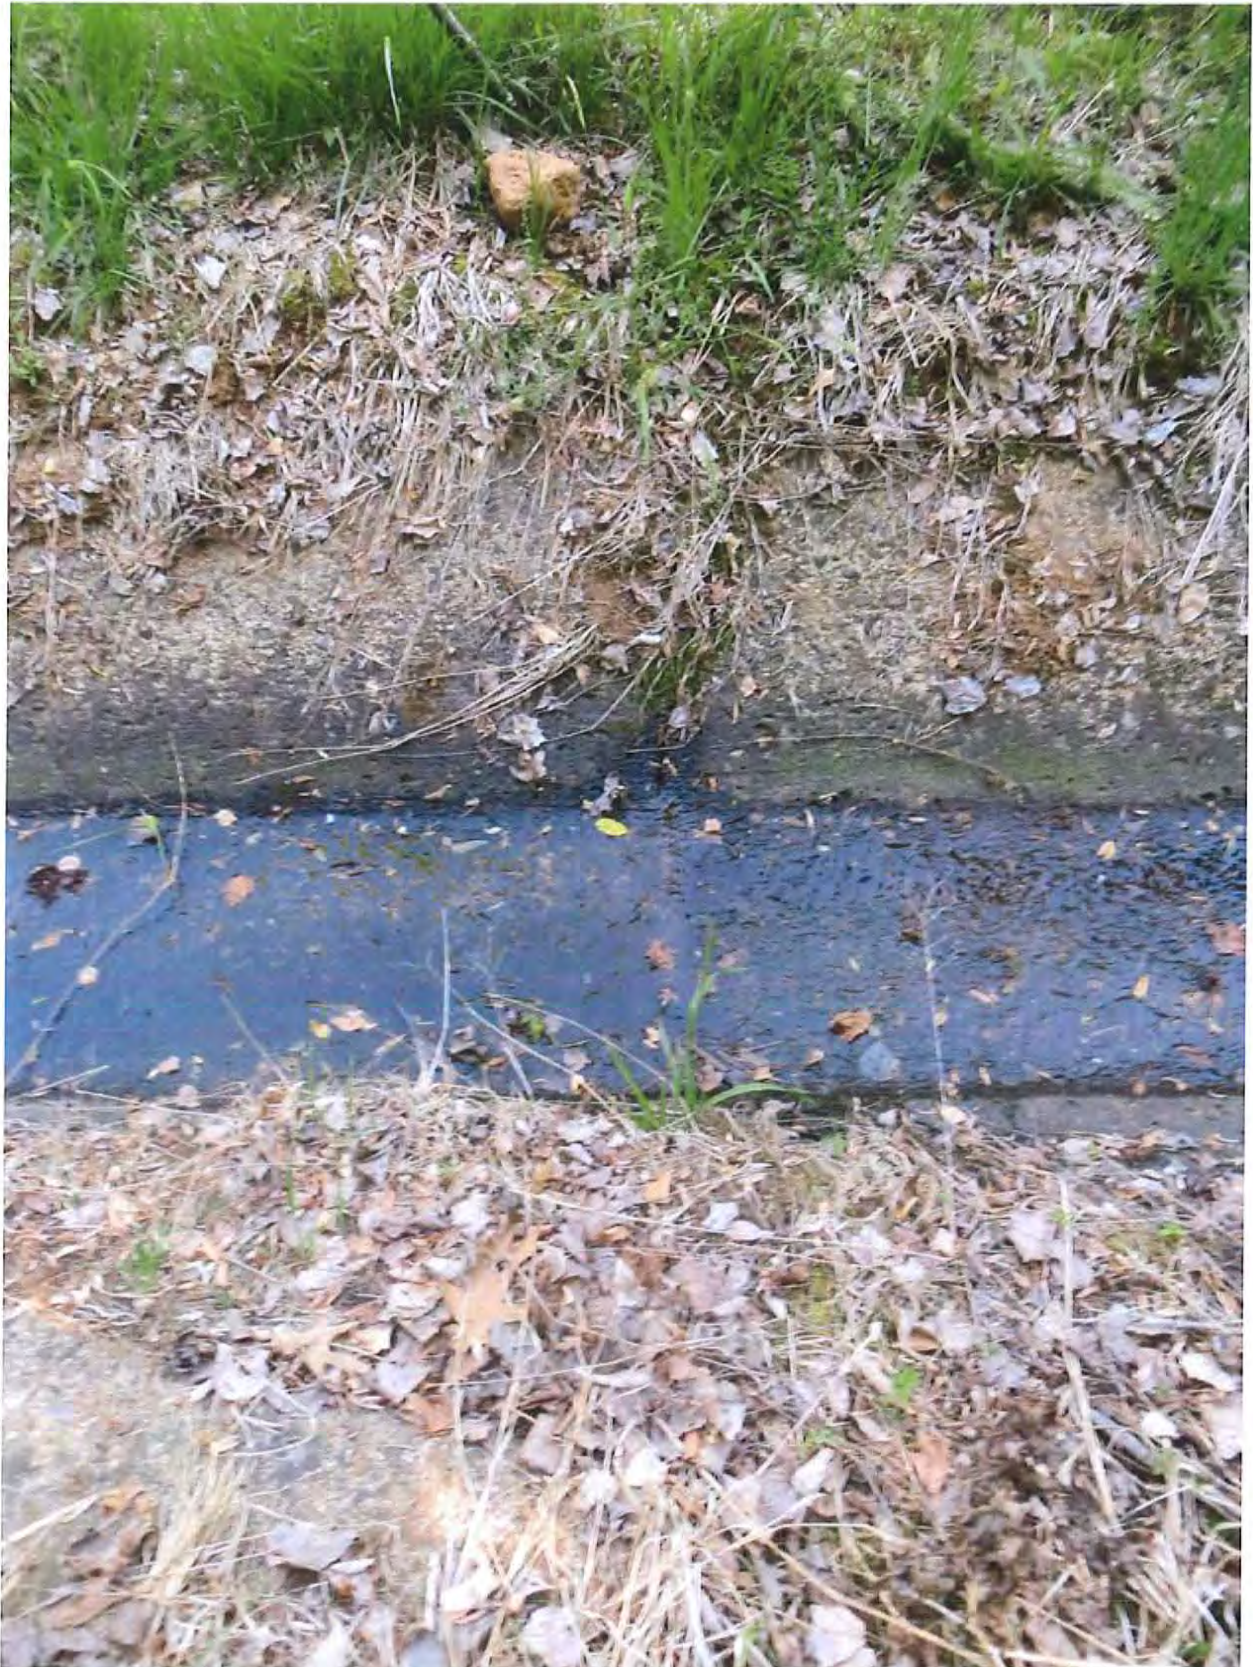
Photograph 17. Photograph of RIVERBEND Seep 12.

Photograph 18. Photograph of RIVERBEND Seep 12.
